Experimental Study ND 96-04

**Evaluation of CRAFCO  
Crack Sealant on  
Asphalt Pavements**

**Final Report**

Project H-5-085(004)041

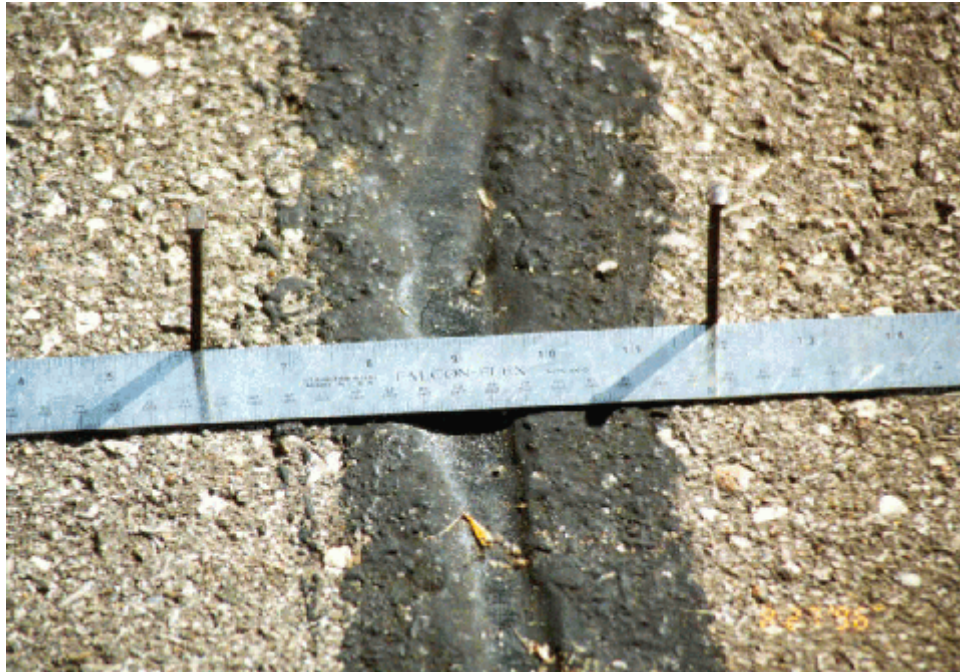
Photo 2  
Method for nail installation.

Measurements between the nails are taken each winter. The ruler in photo 2 was used for demonstration only. Actual measurements are taken in millimeters. These measurements are to determine how much the transverse crack opens up under cold conditions. A comparison can be made to the bond extension percent for each tested material. Cracks are routed to obtain a  $\frac{3}{4}$ "  $\times$   $\frac{3}{4}$ " reservoir. A crack like this would have to expand  $\frac{3}{4}$ " to receive a 100% extension.
